Highway Safety Group  
By, Chad Dornsife  
October 20, 2010

**Re: WSDOT Solar Powered Centerline Delineation Test**  
Oso, WA • SR 530 • 2.25 mile segment • MP 32.75 to 35.00

### Post Installation Synopsis Looking Forward

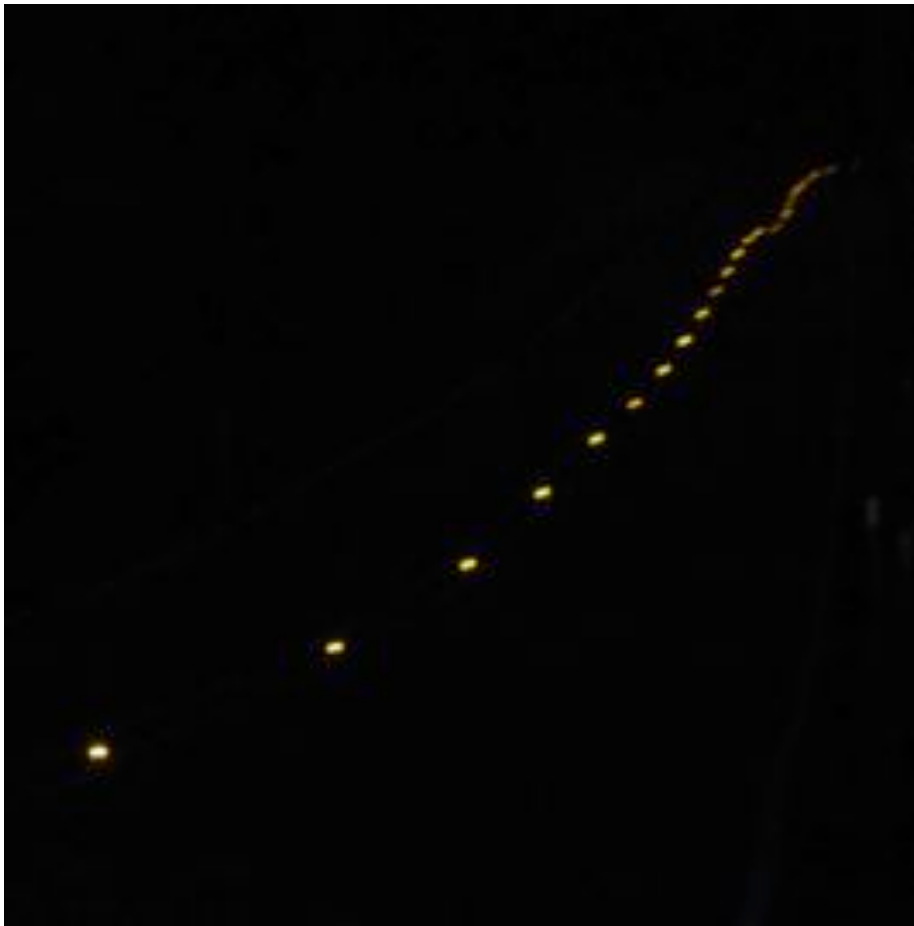
Figure 1: WSDOT - SR 530 – 900 plus feet of no passing zone with undulating terrain; Astucia flush studs milled-in subsurface on 40' centers

1 A single string of internally illuminated raised, flush or subsurface markers can successfully convey unique bi directional advanced guidance for passing and no passing exclusion zones as well as the nature of the changing terrain and curves ahead, illuminated studs only in Figure 1;

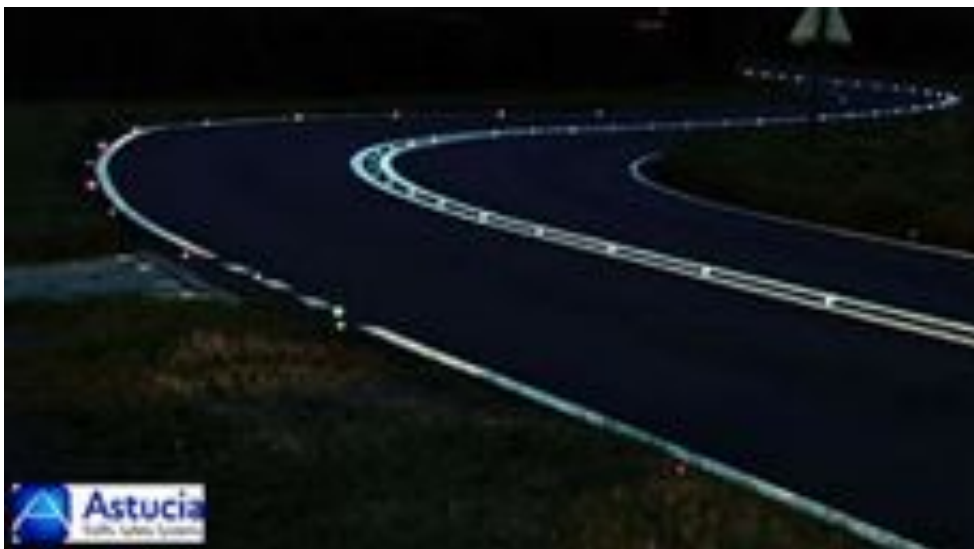
Figure 2: Astucia - clear guidance without distraction.

5. Conspicuity and pattern densities. In the UK Astucia set their luminance to 1 candela to provide clear guidance without distraction taking into consideration their pattern densities and spacing. Except for spacing guidance pattern same as WSDOT.

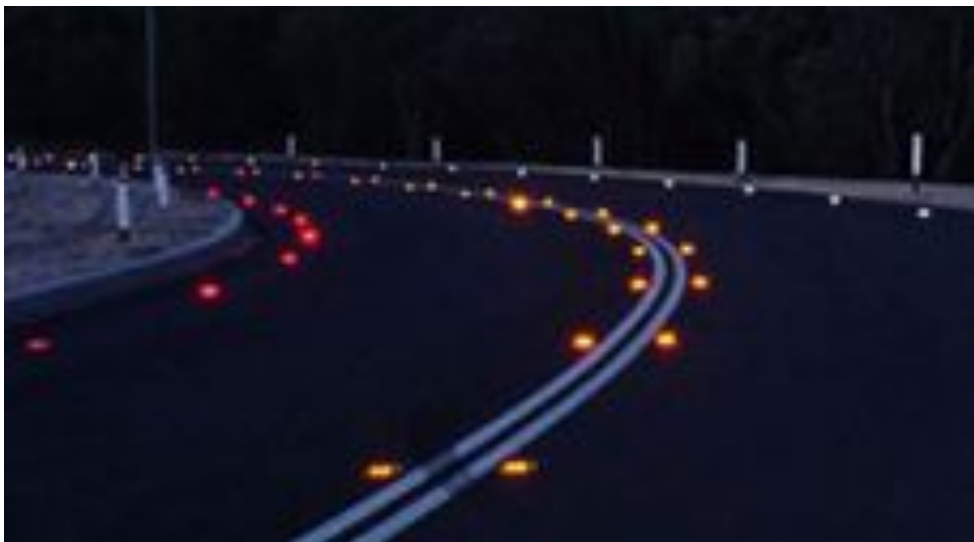
Figure 3: Brand X - too much luminance and distracting patterns.

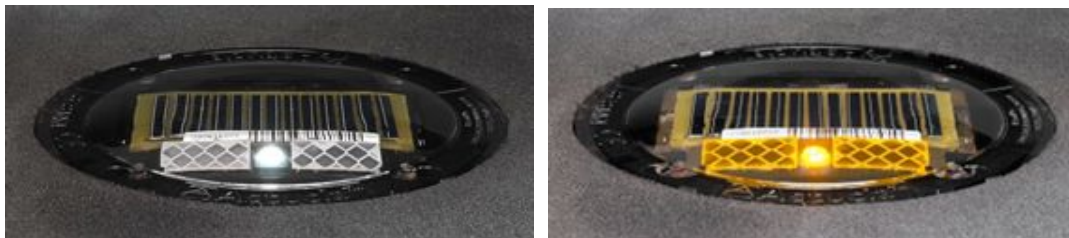
Figure 4;6: Astucia 1 candela white and amber stud conspicuity comparison

WSDOT spacing is MUTCD based but in adverse weather zones (fog etc) a closer spacing regime may be warranted, Additionally, because of our greater spacing and the conspicuity differences between white and amber light, suggest Astucia explore increasing their amber stud's perceived conspicuity to be on par with their white counterparts for North American centerline applications. White studs are visible up to 900m.

Special installation considerations: Astucia flush studs were designed for temperate or snow zones with rubber bit snowplows. The stud optics are only 4mm (0.15") above road surface (Figures 5;6), thereby maintaining site distance and conspicuity while making them impervious to dynamic forces.

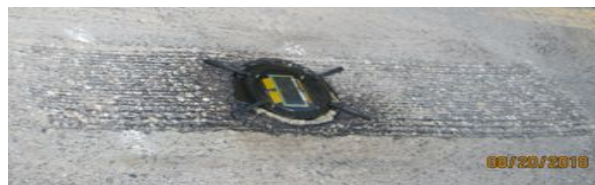
Figure 7: Milled-in Astucia flush stud

In this instance SR 530 is in a snow zone where steel snowplow bits may be used during extreme storms. Therefore we subsurface mounted the studs with 6mm deep milled slots to maintain sight distances.

Regardless of the depth of the mill we set the top of the stud 1/8 inch below the road surface to maintain continuity in sight distance, we then filled in around the stud (not shown) to protect it and the edges of the holes. With the production configuration this QC would all be done in one pass/step.

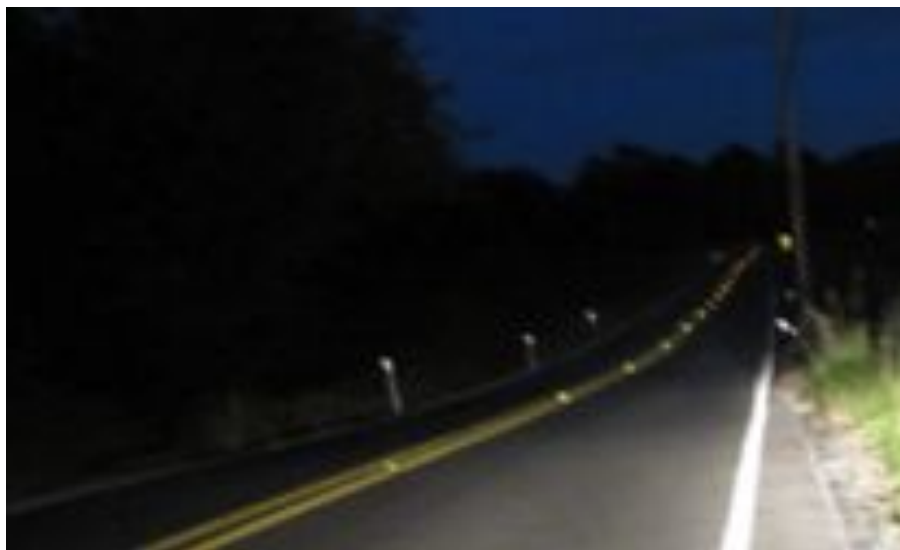
Figure 8: Astucia flush studs milled-in between double yellow lines

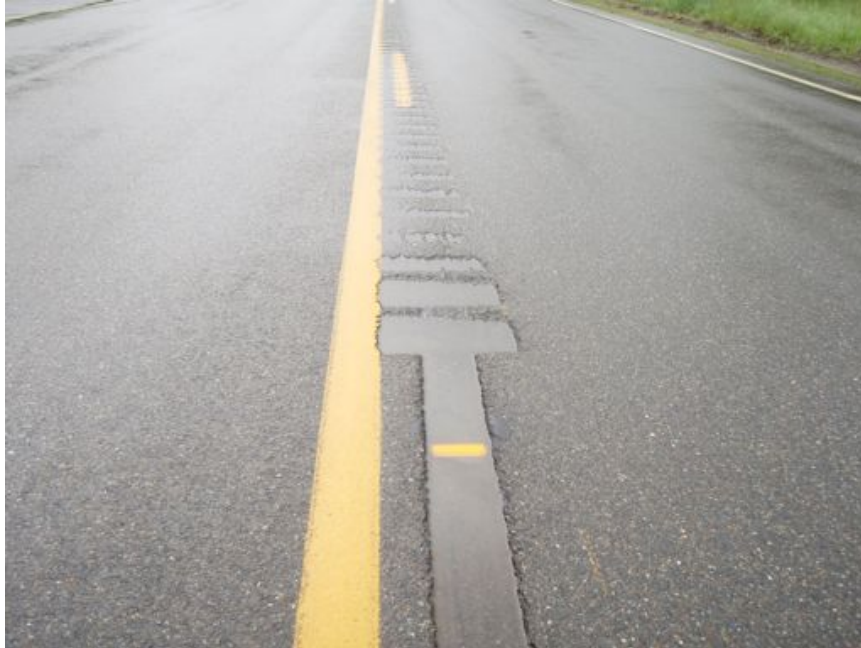
On east end of the SR 530 test site current recessed RPM not visible/apparent in the rain etc and their subsurface mounting causes sight distances to be erratic and foreshortened.

Figure 10: Typical milled-in pavement marker on SR 530 east of test.

The grooves readily fill with water or debris from sanding etc. In weather events headlights reflect off surface of water, thereby eliminating their conspicuity altogether, or they become hidden from view by debris.

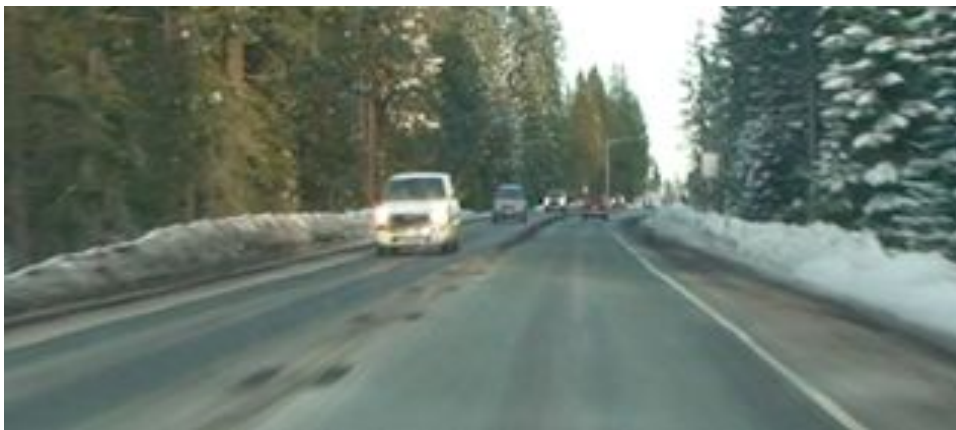
Figure 11 is a debilitating debris example, the reflective surface of the stud is well below the road surface and it takes considerable time after a weather event to clear them - again ineffective when needed most.

Figure 11: Caltrans – Highway 89 - studs covered for extended periods

When milled-in Astucia studs are still visible when covered with water and one tire pass clears the water from the shallow groove, and a few passes will clear debris enough to see the raised light source. In addition, Astucia's lenses are made of a material that is polished by tires.

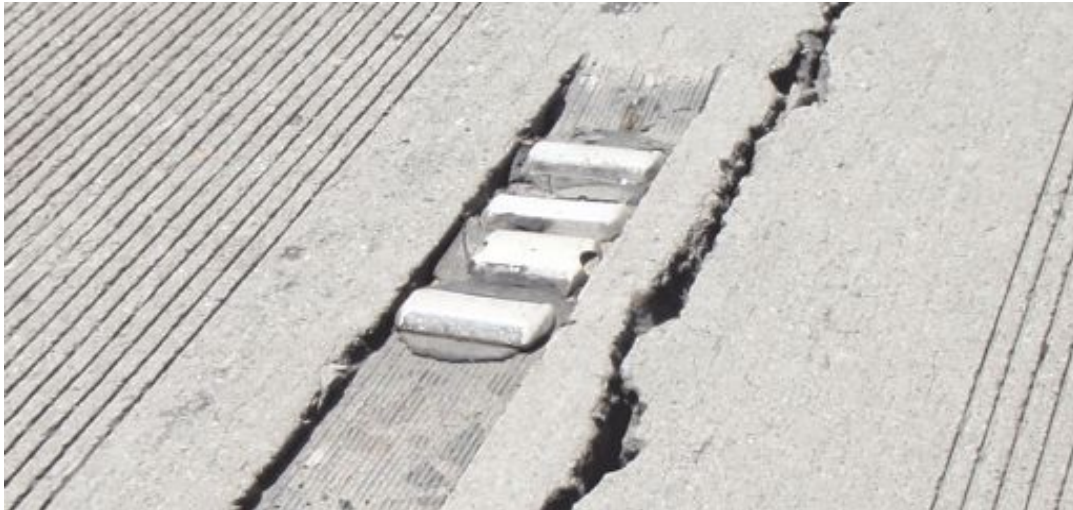
When clear of debris or water the reflective surfaces are short lived, site distances are foreshortened, and despite their subsurface mounting they're only viable during good weather and require frequent replacement.

Figure 12: Caltrans – I5 Grapevine – effectiveness short lived

Adverse weather and conspicuity mitigation: Astucia's flush studs remain visible in rubber plow bit or a temperate zone because their internal light is located above the roadway surface and it has a 10 day power reserve. Having the light source above the pavement is always the best guidance solution if it can be accommodated.

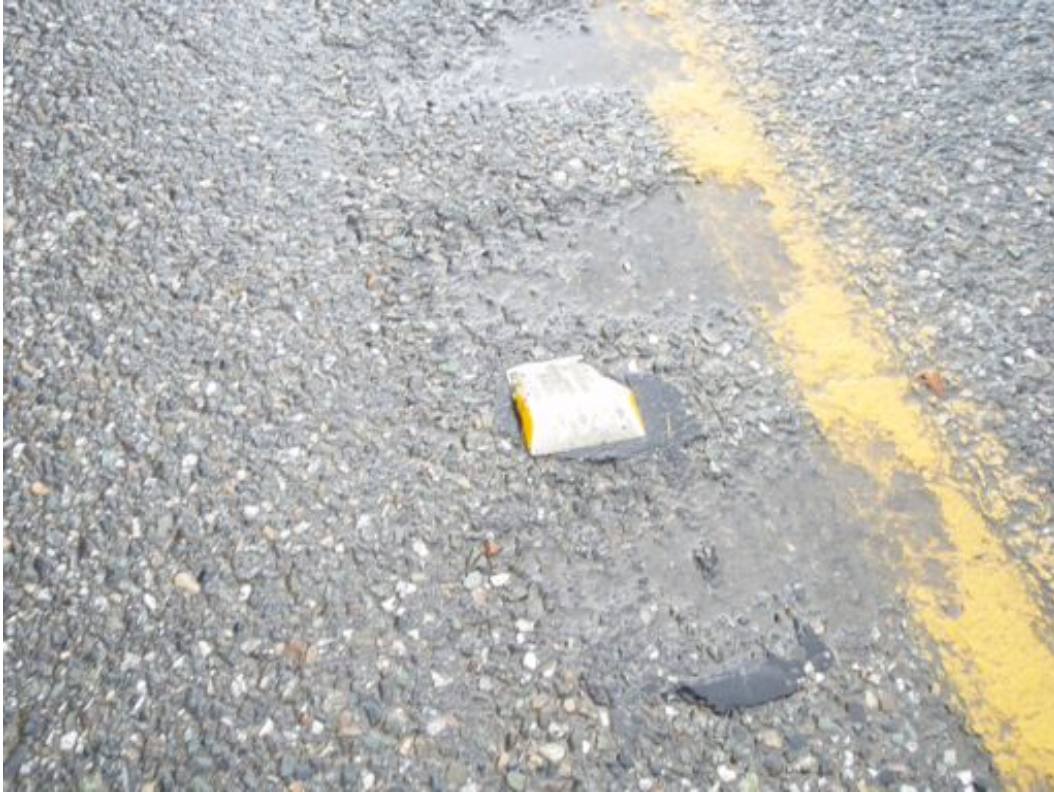
Dynamic loading, high-speeds and lateral forces significantly foreshorten raised pavement marker service life. Likewise, SR 530 has significant truck traffic and the effects of dynamic loading cannot be overstated on these classifications of roadways. WSDOT has about 7,000 miles of roadway to maintain and even with a 2-year cycle, their striping crews have to work hard because of their short maintenance seasons to stay ahead of their 2 lane highway needs.

Universally 2 lane roadways with raised pavement markers begin to have failures within months, and by the time these low volume roads can be serviced again considerable numbers of the markers have been damaged or are missing (Figure 12); sometimes for significant distances or individually in ways that detract from their guidance except as a general centerline demarcation.

Figure 12: Typical 2 lane road missing markers and degradation

Dynamic loading and severe traffic mitigation - Regardless of dynamic loading, lateral forces on curves or wheel hop from the centerline rumble strips the Astucia stud's low profile design (.15 inch above; milled .125 below) is unaffected by these destructive forces. In heavy tire chain zones a .20 subsurface depth may be warranted.

On roadways with existing milled in raised pavement markers, replace a few segments with the Astucia solar surface mount studs thereby adding the advantages of the enhanced LED guidance. The improvement in conspicuity and advanced guidance would be readily apparent if a controlled installation-setting regime was also implemented.
